**Flood Control Project Maintenance  
Levee Inspections****LMA District Cover Sheet****Spring 2012 Levee Inspection Results****Reclamation District No. 0341 Sherman Island**

**Levee Inspection Report By Mile - Spring 2012**

**Reclamation District No. 0341 Sherman Island**

Waterway					Bank	Unit Miles	Inspection Start/End	Inspector
Unit No. 01 Threemile Slough					Right	3.34	03/15/2012 03/15/2012	Herman Phillips

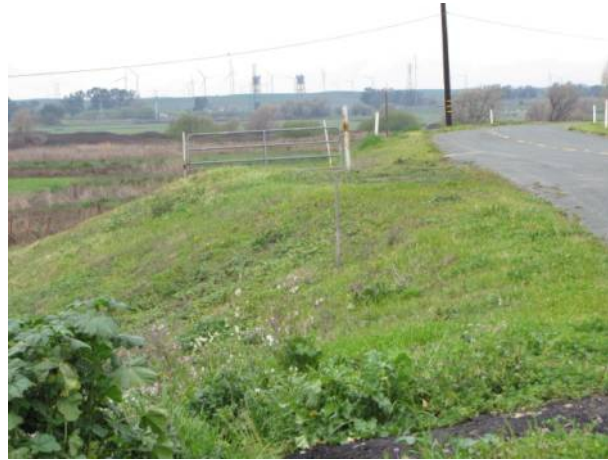
Levee Mile Report Line	4
Start Levee Mile	0.00
End Levee Mile	0.00
Location	Land Side
Category	Earthen Levee
Item	Vegetation

RD 341 landside slope at levee mile 0.00 looking downstream. This photo was taken 3-15-2012.

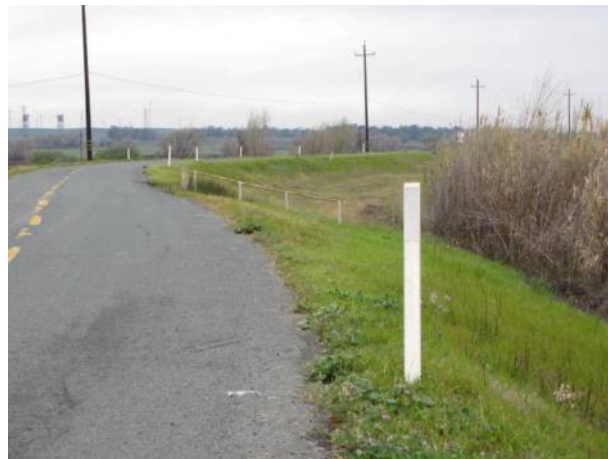
Levee Mile Report Line	5
Start Levee Mile	0.00
End Levee Mile	0.00
Location	Water Side
Category	Earthen Levee
Item	Vegetation

RD 341 looking downstream from waterside levee mile 0.00. Photo taken 3-15-2012.

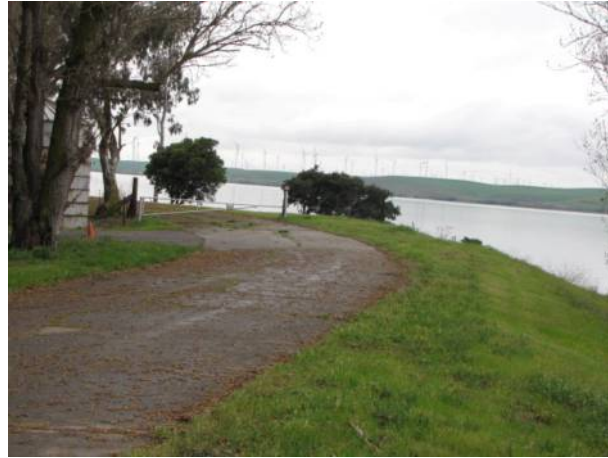
Levee Mile Report Line	2
Start Levee Mile	3.36
End Levee Mile	3.36
Location	Water Side
Category	Earthen Levee
Item	Vegetation

Levee mile 3.34 start of Unit 2 looking downstream from waterside. Photo taken 3-15-2012.

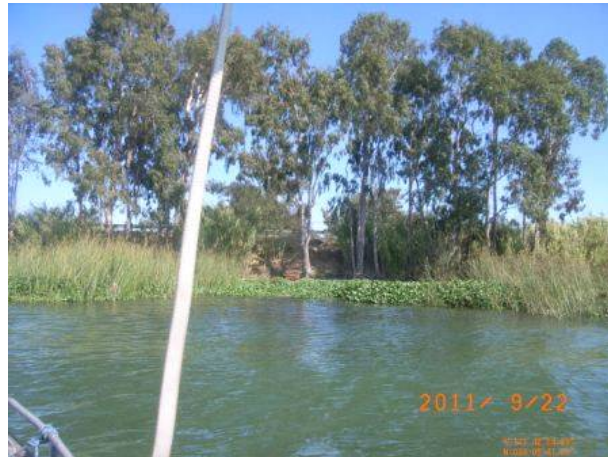
Levee Mile Report Line	4
Start Levee Mile	4.14
End Levee Mile	4.17
Location	Water Side
Category	Supplemental
Item	USACE Erosion Survey

USACE 2011 Photo #1

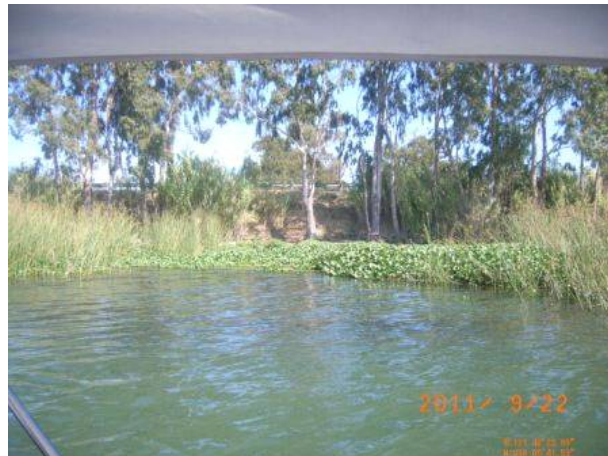
Levee Mile Report Line	4
Start Levee Mile	4.14
End Levee Mile	4.17
Location	Water Side
Category	Supplemental
Item	USACE Erosion Survey

USACE 2011 Photo #2

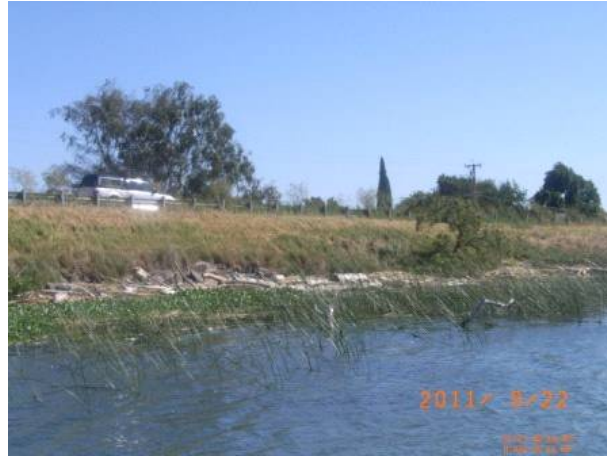
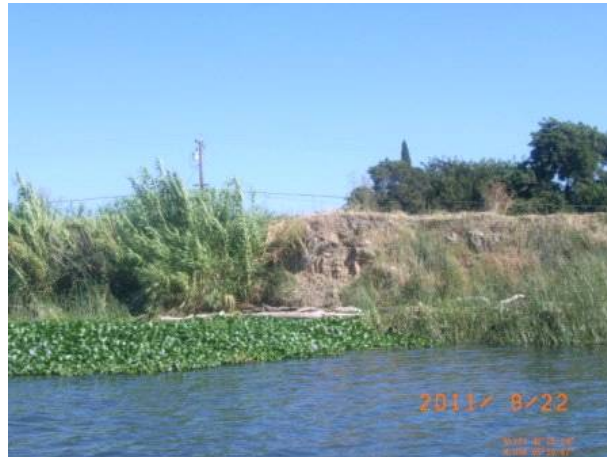
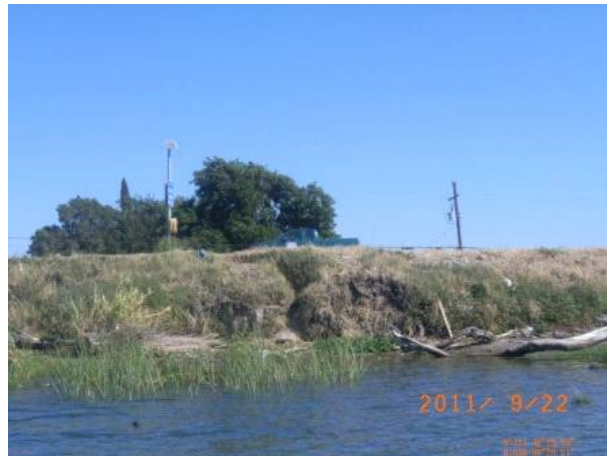
Levee Mile Report Line	5
Start Levee Mile	4.32
End Levee Mile	4.50
Location	Water Side
Category	Supplemental
Item	USACE Erosion Survey

DWR ID: DWR_RD0341_02_s_2012_5										
5	4.32	4.50	Supplemental	USACE Erosion Survey	WS	M Ma	Inspector Comments: 1999 - New small slump in eroded bank. 2005 - Reach extended because of vertical bank along the roadway upstream. 2011: More slumping since last year. [2011 Site ID: SAC_8-0_L]	38.090620 ° -121.706684 °	38.088572 ° -121.707127 °	7 Y
DWR ID: DWR_RD0341_02_s_2012_7										
6	4.58	4.65	Supplemental	USACE Erosion Survey	WS	M Ma	Inspector Comments: 2011: Large slump section [2011 Site ID: SAC_7-9_L]	38.086603 ° -121.707786 °	38.086110 ° -121.708114 °	8 Y
DWR ID: DWR_RD0341_02_s_2012_8										
7	5.49	5.81	Earthen Levee	Trim / Thin Trees	LS	M Ma	T1 : Trim trees to at least five feet above ground level.	38.081252 ° -121.719488 °	38.080513 ° -121.725628 °	10
DWR ID: DWR_RD0341_02_s_2012_10										
8	5.98	6.03	Supplemental	USACE Erosion Survey	WS	U Ma	Inspector Comments: 2011: Large slump at downstream end. Gully formed from surface runoff from the road. Shallow slumping throughout site. [2011 Site ID: SAC_7-3_L]	38.080526 ° -121.730483 °	38.080370 ° -121.728341 °	9 Y

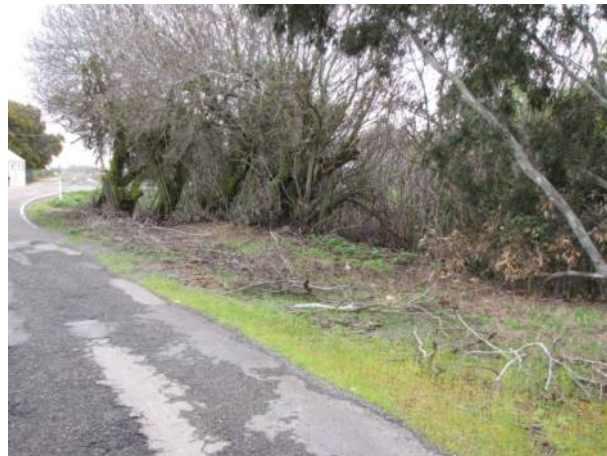
Levee Mile Report Line	9
Start Levee Mile	6.21
End Levee Mile	6.35
Location	Land Side
Category	Earthen Levee
Item	Trim / Thin Trees

DWR ID: DWR_RD0341_02_s_2012_9										
9	6.21	6.35	Earthen Levee	Trim / Thin Trees	LS	U Ma	T3 : Trim and thin trees to allow visibility of the ground and room to flood fight.	38.080723 ° -121.731799 °	38.081545 ° -121.735244 °	11 Y
DWR ID: DWR_RD0341_02_s_2012_11										
10	7.92	8.10	Earthen Levee	Encroachments	LS	M En	FE : Fences	38.073268 ° -121.759500 °	38.072275 ° -121.762510 °	6
DWR ID: DWR_RD0341_02_s_2012_6

Wild growth covering slope and toe of levee section landward Unit 2 levee mile 6.21. Photo taken 3-15-2012.
